PLANNED PREVENTATIVE MAINTENANCE

Gang Warily Recreation Centre Outbuildings

Client: Fawley Parish Council

31st March 2023

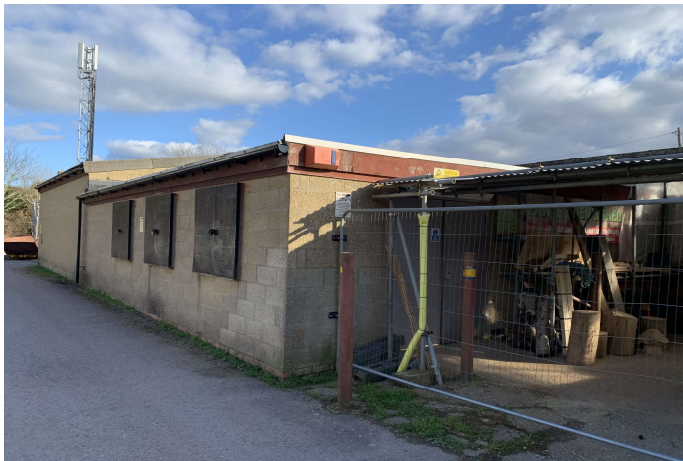
Figure 2 - Building A

3.3.3	Building A flat roof covering	Building A has a mineral felt roof covering applied to the flat roof. The roof covering is in satisfactory condition.	B	Remove existing mineral felt roof covering. Supply and install new high performance mineral felt roof covering and undertake any thermal upgrade requirements when removing the roof covering.	3					£7,560.00

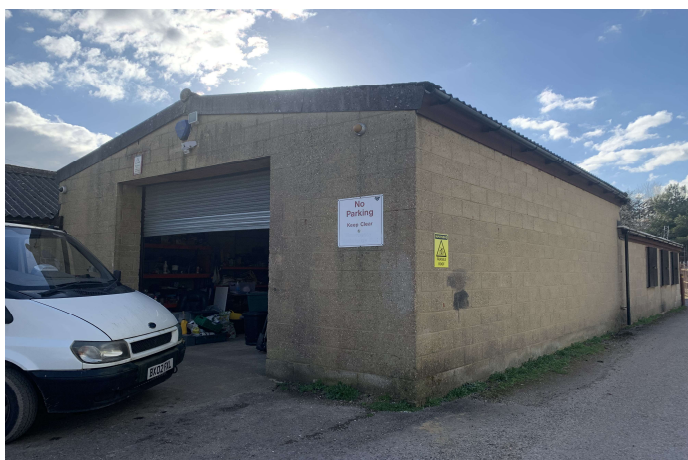
Figure 3 - Building B

3.3.1	EXTERNALS									
3.3.2	Asbestos cement corrugated roof panels	Buildings B and C have a pitched roof with asbestos cement corrugated roof cladding panels forming the roof covering. The cladding panels would be deemed to be at the end of their serviceable life.	D	Remove and discard asbestos cement roof panels in specialist waste. Supply and install lightweight composite or aluminium corrugated cladding to existing roof structure. Structural engineer would be required to confirm existing roof structure is adequate to take the load of the new roof covering.	3			£40,000.00
